# TP006 LONG TERM PERFORMANCE OF PVC PRESSURE PIPES

ISSUE 01 / AUGUST 2012

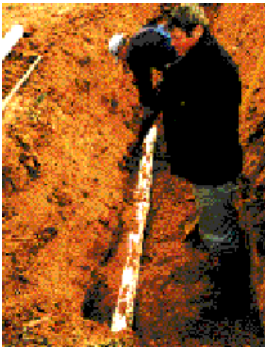
Pipes were surrounded by granular material obtained from the excavation or, in the case of rock excavation, from nearby.

A layer of granular material was placed beneath the pipe to a minimum depth of 75 mm throughout the project, including areas of rock excavation.

Typical trench conditions are illustrated in the photo at left.

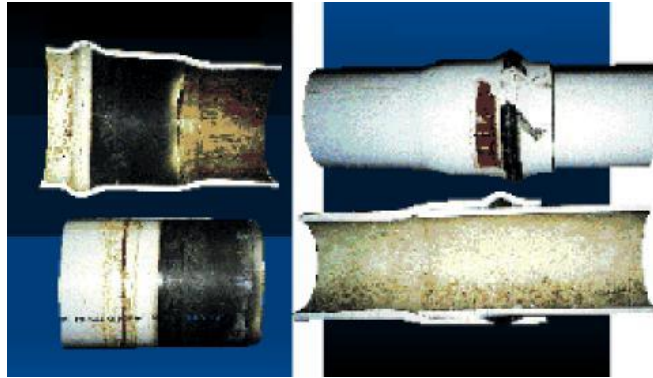
Polidex Rubber Ring Joint Rubber Ring Joint

Elastomeric seal joints as exhumed and subsequently sectioned are depicted below.

Dark staining is evident on the matching socket and spigot surfaces where the water would be essentially dormant. This staining is likely to be due to sulphides reacting with the lead stabiliser in the pipe. The staining is only a surface effect.

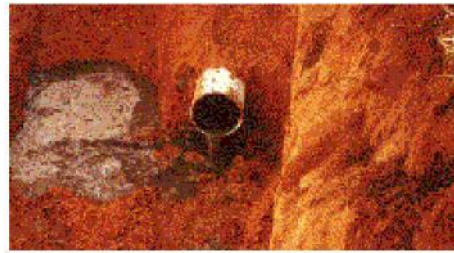
Some pipelines are currently "contaminated" by a grey "sludge", as can be seen in the photograph shown at right.

This material is thought to be at least partly composed of dead organisms and has had no apparent effect on the performance of the PVC pipes.
