# LONG TERM PERFORMANCE OF PVC PRESSURE PIPES IN A LARGE RURAL WATER SUPPLY SCHEME

M. W. Stahmer<sup>1</sup> and A. J. Whittle<sup>2</sup>

<sup>1</sup> Vinidex Pty Ltd, Australia. <sup>2</sup> Iplex Pipelines Australia Pty Limited.

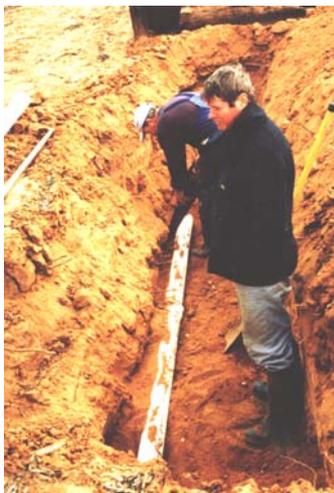
**Figure 1.** Trench Conditions

Typical trench conditions are illustrated in Fig. 1.

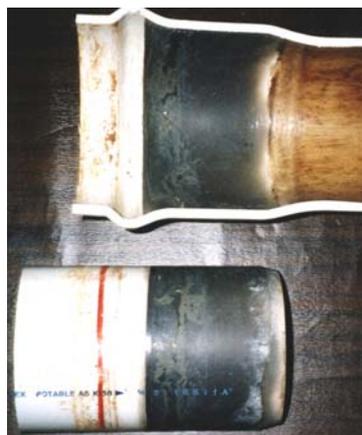
**Figure 2.** Typical RRJ

Elastomeric seal joints as exhumed and subsequently sectioned are depicted in the Fig. 2. Dark staining is evident on the matching socket and spigot surfaces where the water was essentially dormant. This is likely to be due to sulphides reacting with the lead stabiliser in the pipe. The staining is only a surface affect. There was no evidence of loss of elastomer due to microbiological attack.

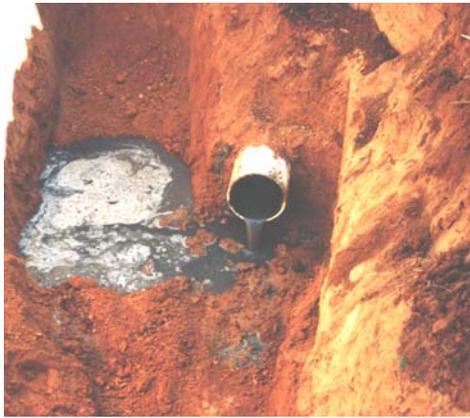
**Figure 3** Sludge from the bottom of the pipe.

**Water Quality** - As mentioned above, the possibility of lead extraction adversely effecting the water quality was investigated and discounted early in the project. Some pipelines are currently "contaminated" by a grey sludge [fig. 3]. This material is thought to be at least partly composed of dead organisms and has had no apparent effect on the performance of the PVC pipes.

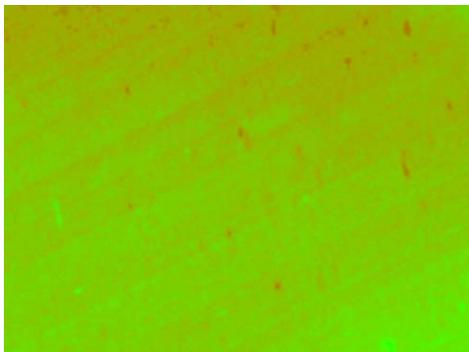
**Figure 4.** Dispersion of Humes 8'' Pipe

The polymer dispersion (residual structure of the PVC grains), was judged by comparing microtomed sections with in-house, reference photographs used by the Australian PVC pipe manufacturers. The results were variable and generally not as good as current production [figure 4].

The degree of gelation and the quality of the dispersion would be expected to be higher with contemporary PVC pipe production. Nevertheless, the performance of the pipes has not been adversely affected by these factors.

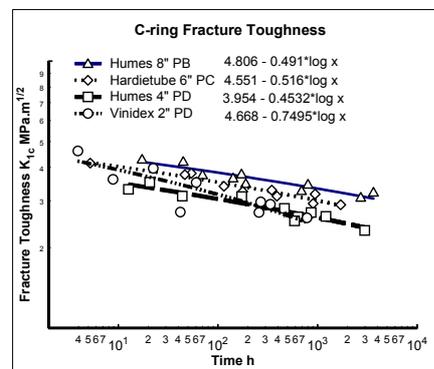
**Figure 5** C-ring Fracture Toughness

The fracture toughness versus time-to-failure results were plotted [ fig 5]. The fracture toughness at 15 minutes ranged from 4.2 to 5.1 MPa m<sup>1/2</sup> for the four pipes tested.

The fracture toughness of all the samples tested was much higher than the values reported by Lyall (10) and J. M. Marshall et al (11) for pipe made in the UK at about the same time. In addition, the fracture toughness was comparable to, or exceeded, the value now expected for well-processed PVC pressure pipes. These results imply there has been no deterioration in the fracture toughness during a service life approaching 30 years.
