# **PREDICTING THE RESIDUAL LIFE OF PVC SEWER PIPES.**

**A. J. Whittle** Iplex Pipelines Australia Pty Limited.

**J. Tennakoon** Ipswich Water, Queensland, Australia.

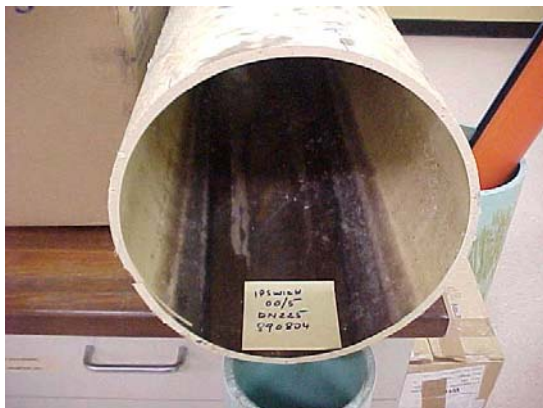
The wall thickness of each pipe was measured by micrometer at 45° intervals around the circumference, starting at the crown. The crown was identified by the markings made at the time of exhumation and was confirmed by the location of the black, sulphide staining at the invert of the pipe (Fig. 1).

Figure 1. Sulphide staining at invert.

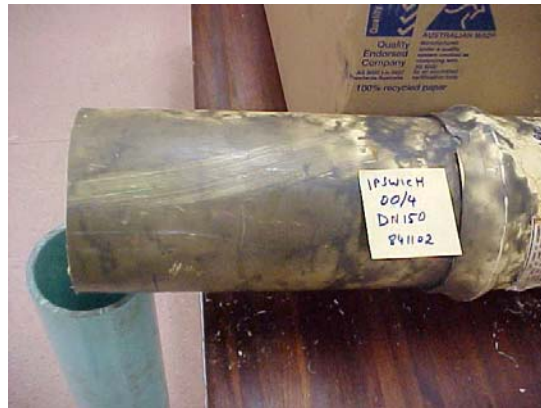
With the exception of sample 00/4, all the joints passed both the infiltration and exfiltration tests. Sample 00/4 leaked in both tests because of damage to the spigot that apparently caused by an excavator. There was a long score mark along the top of the spigot which ended at the socket which was also damaged. The stress that had been applied to the top of the pipe was sufficient to permanently distort the spigot (Figs. 2 – 3). There was also damage evident on the socket of 00/6 (Fig. 4) that looked like a crowbar or tooth from an excavator had caught the lip of the socket. This did not cause failure in either the pressure or vacuum test. It was observed that many of the pipes exhibited a staining pattern that had the appearance of tree roots in contact with the pipe (Fig.5). The results show that except in the case of the damaged spigot, the joints have maintained their integrity for up to 25 years and continue to meet the infiltration and exfiltration requirements of new pipe as specified in AS/NZS1260.1999

Figure 2. Damaged Sample 00/4.

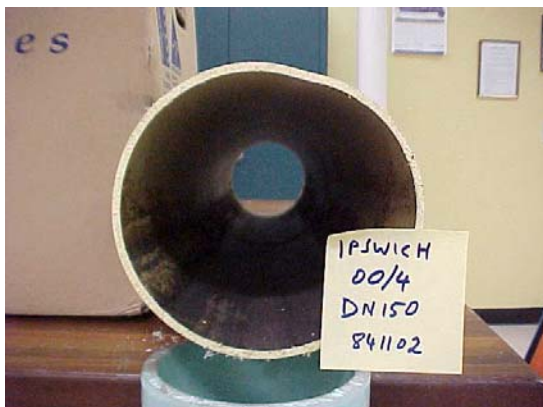
Figure 3. Distortion in spigot of 00/4.

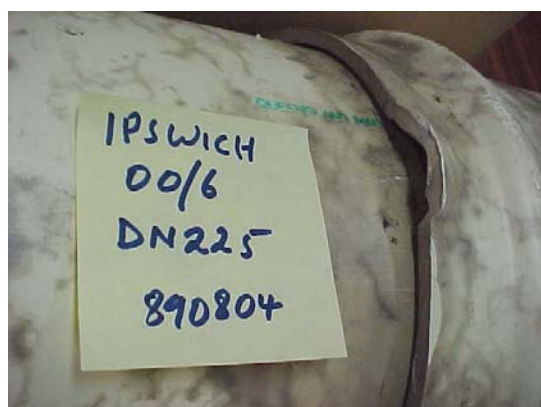
Figure 4. Damage to socket of 00/6.

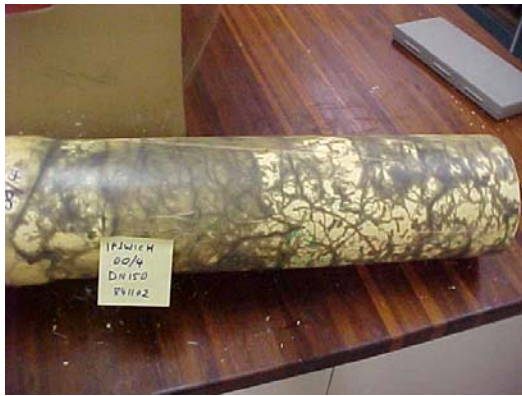
Only the DN225 joints exhibit an interface pressure that meets the minimum requirements of the product Standard, AS1260-1984 (Table 2). That is, an initial interface pressure of not less than 0.55 MPa over a continuous length of at least 7mm. All the DN150 joints, except the damaged 00/4, exceeded the interface pressure of 0.4MPa over at least 4mm, as required by the current version of AS/NZS1260. When the joints were disassembled for the interface pressure test, there was no evidence of microbiological attack on the rubber. Nor was there any suggestion of tree root intrusion despite the external staining pattern that implied tree roots were in close proximity to many of the pipes.

Figure 5. Typical external staining pattern. Figure 6. Wall thickness of individual pipes.

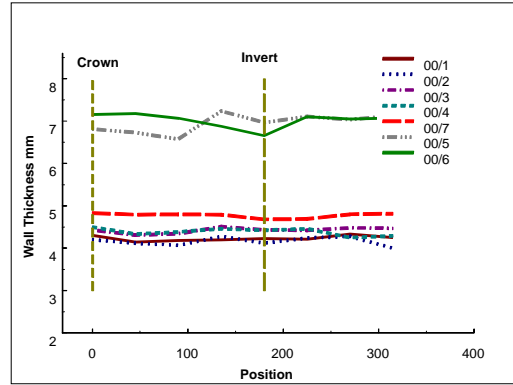
The wall thickness of each pipe, measured around the circumference at 45° intervals was plotted against the circumferential position (Fig 6). It can be seen that whilst there is some variation in wall thickness around the circumference, there is no indication that the wall thickness is systematically lower at the invert. Moreover, there is no suggestion of any difference between the pipes of different ages, as might be expected if there was a loss due to wear. Also, all the pipes still comply with the minimum wall thickness requirements of the appropriate product Standard.

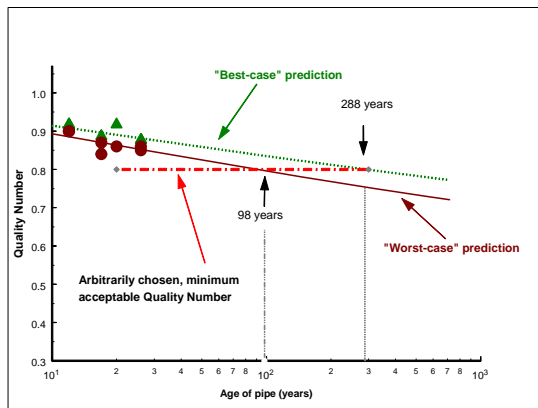
The Quality Numbers for the exhumed pipes versus the number of year's service, are shown in Fig. 7 (a). The graph shows the minimum life expectancy of the PVC pipes tested to be in excess of 98 years. The "best value" weighting factors give a more optimistic predicted service life of almost 300 years. It should be noted that the number of samples tested is only seven and the program should be continued in order to predict the life expectancy with an even greater confidence.

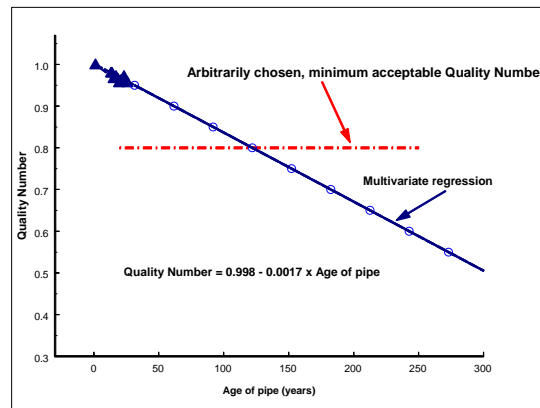
Linear multivariate regression analysis has been applied to the test results and an alternative prediction of service life determined (Fig. 7 (b)). In this analysis, the ratios of *Measured Parameter:Reference Value* for the characteristics in Table 7 were used as independent variables and linear multiple regression analysis was undertaken with *Age* as the dependant variable. This analysis supports the outcome of the judgemental analysis.
