Assessment of NDE Methods on Inspection of HDPE Butt Fusion Piping Joints for Lack of Fusion with Validation from Mechanical Testing

S.L. Crawford, S.R. Doctor, A.D. Cinson, M.W. Watts, T.L. Moran, M.T. Anderson
Pacific Northwest National Laboratory¹, USA

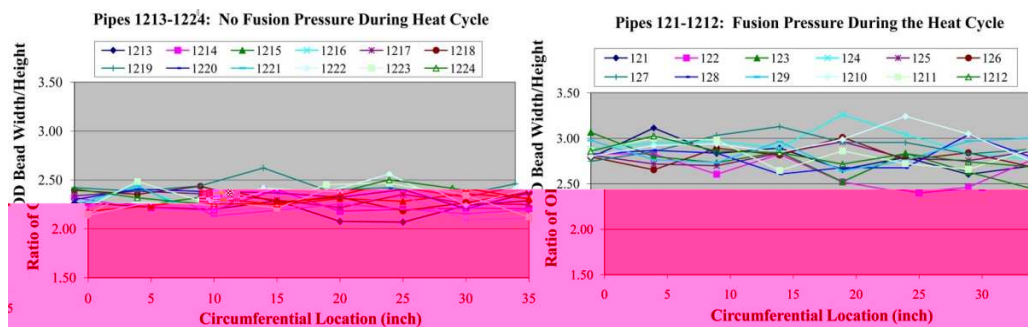
The v-groove depth was not specifically measured but cursory observations showed acceptance of the joints based on v-groove depth. Weld beads also did roll back to the pipe surface. The criterion that caused a rejection of more than half of the pipe joints was in the bead width-to-height comparisons. These values are plotted in Figure 2 for the 24 pipe joints. Data representing the 12 pipe joints that were made under the condition with fusion pressured applied during the heating cycle are on the right. All but 3 data points lie above the acceptable 2.5 bead width-to-height ratio line.

Data representing the other 12 pipe joints that were fused in the standard mode or absence of fusion pressure during the heat cycle are on the left. All of these bead width-to-height values are above the minimum acceptable 2.0 value and only 2 points fall outside the range on the high side (above 2.5) and would be rejected.

Figure 2 - Weld bead width-height values for the 24 pipe joints.
The valid range is between 2.0 and 2.5.

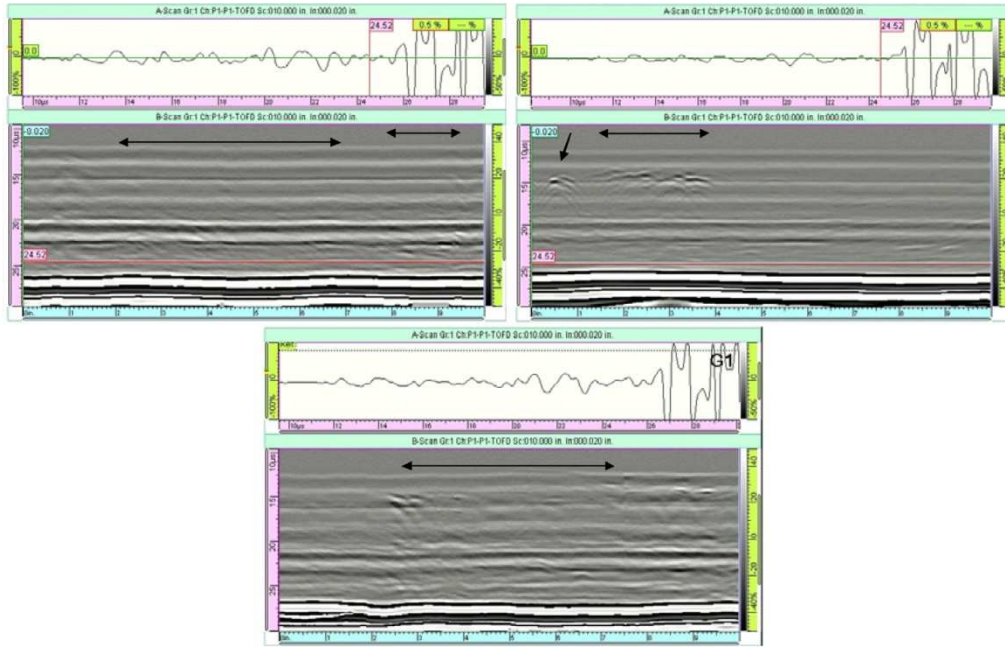
TOFD data as acquired by Fluor/NDT Innovations is displayed in Figure 3. The arrows mark indications called by the inspectors. TOFD data acquired by PNNL is displayed in Figure 4. The Fluor/NDT Innovations data does not show a strong near-surface signal and is in general more sensitive to the material. PNNL data is unprocessed and acquired with commercially available probes. Figure 4 shows the flaw indications detected in pipe 127, which is the worst fusion condition of the five conditions expected to produce lack-of-fusion. A marginally suspect region was noted in pipe 1223 with the dashed line and no indications were found in pipe 123. Finally, the PA data is displayed in Figure 5. These images represent B-scan, end view images acquired at the angle specified in the image. Again, pipe joint 127 clearly shows defect responses while the other two pipe images do not exhibit flaw type responses.

Figure 3 - TOFD data from the first quadrant of pipe joints fused under conditions 1 (top left), 2 (top right) and 6 [(ideal) bottom]. The data were acquired by Fluor/NDT Innovations.

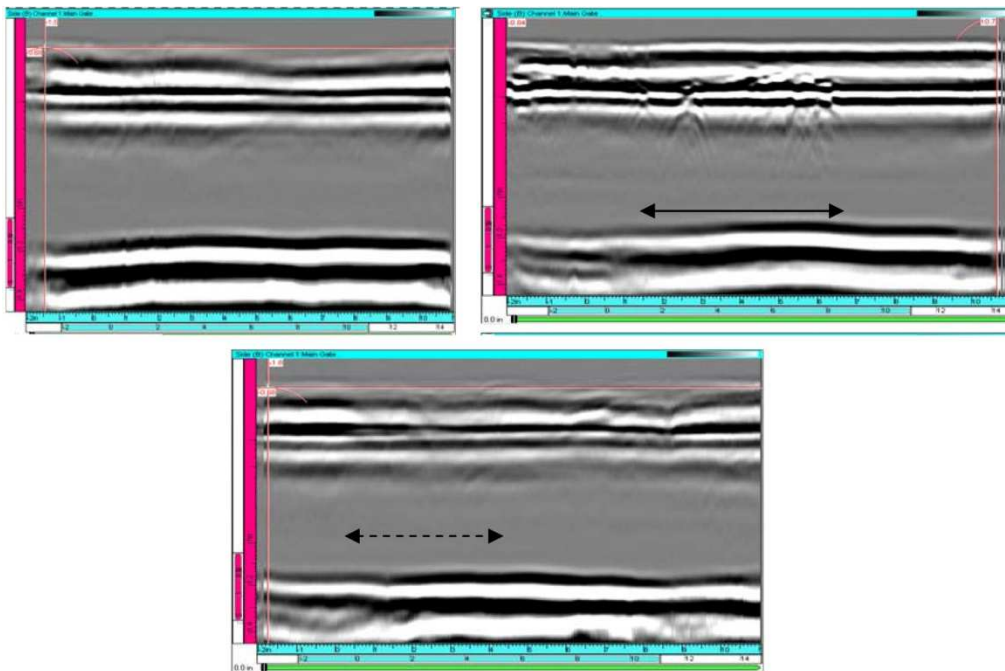
Figure 4 - TOFD data from the first quadrant of pipe joints fused under conditions 1 (top left), 2 (top right) and 6 [(ideal)bottom]. The data were acquired by PNNL.

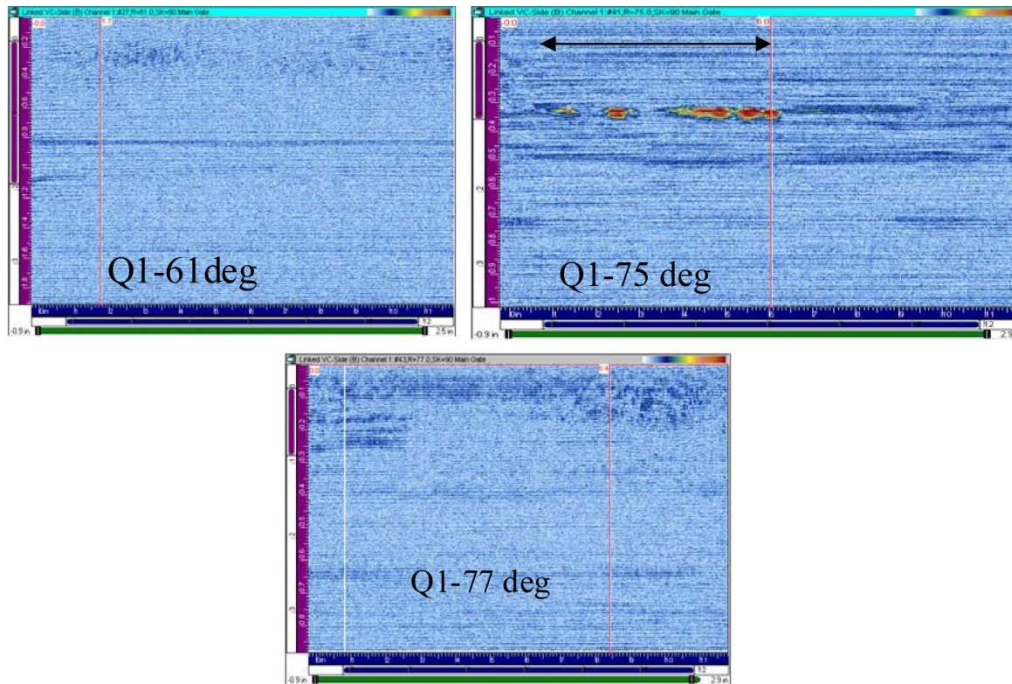
Figure 5 - Phased-array data from the first quadrant of pipe joints fused under conditions 1 (top left), 2 (top right), and 6 [(ideal) bottom]

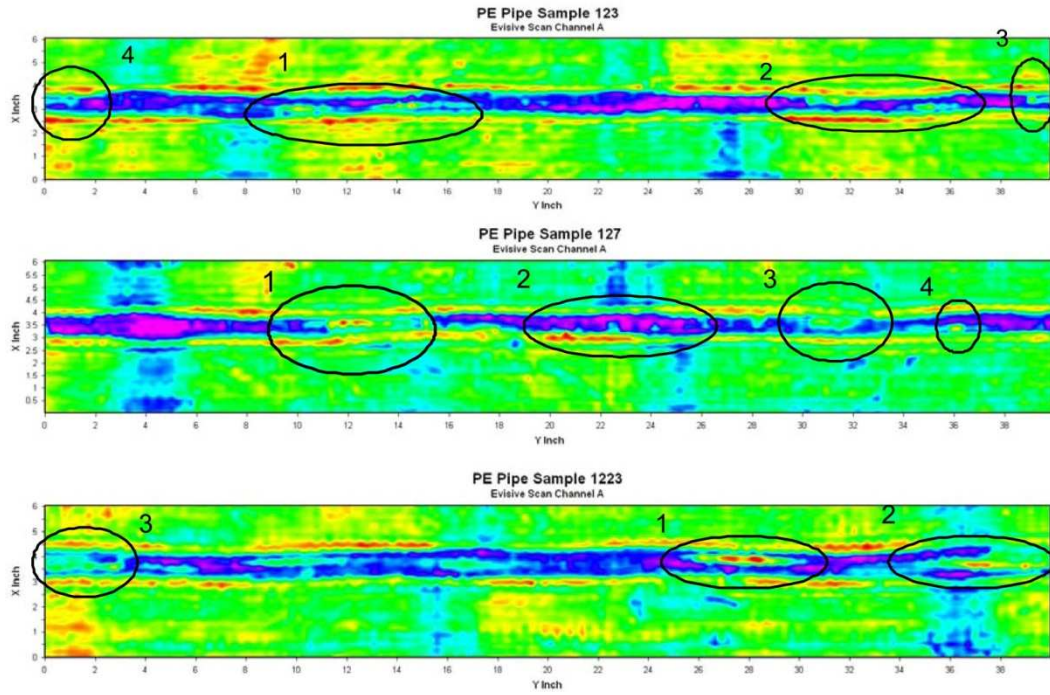
Figure 6 - Microwave data from all four quadrant of pipe joints fused under conditions 1 (top), 2 (middle) and 6 [(ideal) bottom]

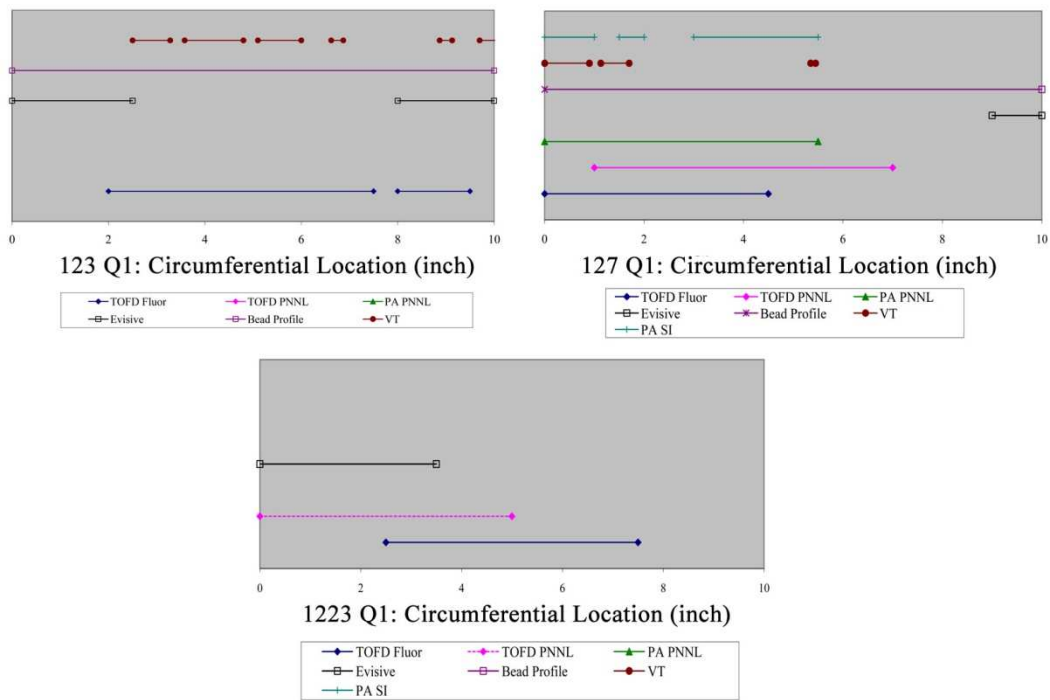
The results from all of the NDE were compiled into summary graphics to facilitate the comparison of results and to feed into the destructive evaluation (DE) to follow. The listed inspections include ultrasonic TOFD as performed by Fluor/NDT Innovations and PNNL, and PA as performed by PNNL and some limited inspections conducted by Structural Integrity. Also included are the Evisive microwave data and VT data as observed from pin holes or anomalies in the v-groove area and VT from bead profile measurements. Specimen summaries for the first quadrant of pipe joints 123, 127, and 1223 are displayed in Figure 7. Indications were found in each of the quadrants by multiple techniques. Dotted lines indicate marginal calls where there was an NDE response but not a typical flaw response. The highest occurrence of detected flaw indications is in pipe joint 127, fused under the most severe condition.

Figure 7 - Compilation of NDE flow indications for the first quadrant from pipe joints 123, 127 and 1223

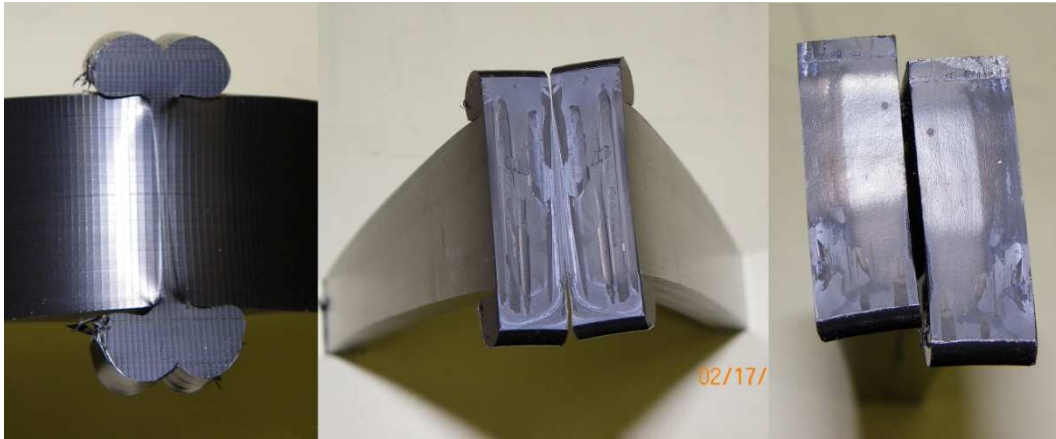
After further discussions and community input, PNNL was directed to the guided bend test as documented in a Plastic Pipe Institute (PPI) draft technical note. The basic guided bend test places either the pipe ID (root bend), pipe OD (face bend), or entire joint (side bend) in tension with a die and plunger arrangement. The plunger or mandrel radius of curvature is designed to be approximately two times the pipe wall thickness (or test coupon specimen thickness). With this radius, a 23% or greater strain is placed on the specimen as it is bent, which is above the lower limit in yield strain. The bend test as outlined by ISCO Industries [4] states a 38% strain is produced in the material. To prepare material for this test, the pipe was cut into 0.75 to 1 inch (19.1 to 25.4 mm) strips that were then run through a planer. Three of the tested strips are displayed in Figure 8. The left and center images are from pipe joint 1224, fused under the standard procedure. The bend test showed no failure on the left specimen, which represents the 3-inch (76.2-mm) circumferential position. A brittle failure is observed in the center image, acquired at 1-inch (25.4-mm) circumferential. A brittle failure is also noted in the right image, acquired from specimen 127, worst fusion condition, at 36-inch (914.4 mm).

Every one of the seven tested strips from pipe joint 127, worst fusion condition, failed in the brittle mode by the side-bend test. This joint was selectively tested at positions containing flaw indications and at positions without flaw indications. Each piece failed rapidly; that is, minimal plunger displacement was needed to cause failure. From this result, PNNL assumed that the entire pipe joint would similarly fail and it was not tested further. Pipe joints from the remaining five fusion conditions were subjected to the bend test over two full quadrants. The results of these bend tests were color coded for a summary presentation. Figure 9 displays the results from pipe joints 123 and 1223, fusion conditions 1 and 6, respectively. Quadrant 1 starts at the top zero mark and proceeds counter-clockwise. A green region represents no flaw, light green indicates a small flaw with both ID and OD ligament intact, yellow indicates the joint opened but had either an intact ID or OD ligament, and the red indicates a through-wall failure. The other tested joints similarly had good regions and regions that failed. PNNL is currently evaluating these findings and correlating the DE and the NDE results.

Figure 8 - Bend test results on pipe joint 1224 (standard fusion procedure), left two images, and on pipe joint 127 (worst fusion condition) on the right

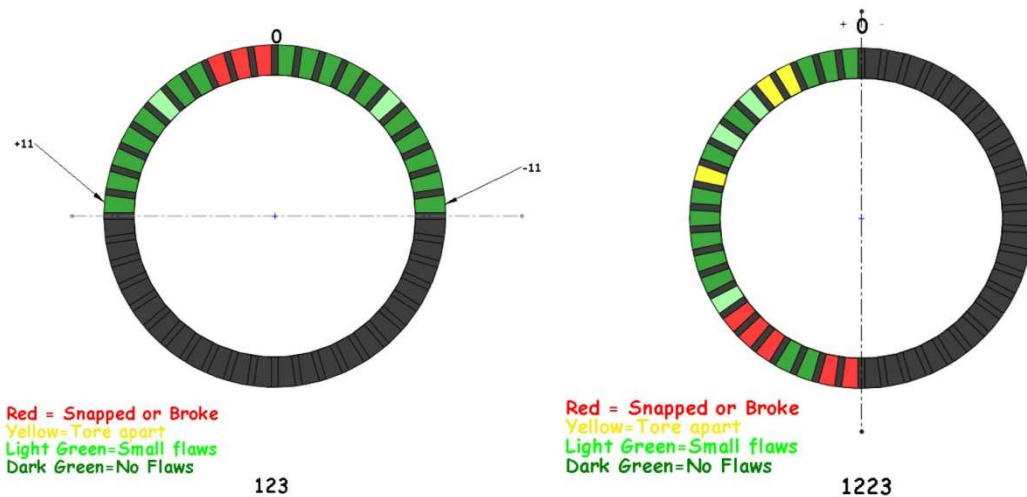
Figure 9 - Side-bend test results on pipe joints 123 and 1223
