PVC Pipe Bore Rippling

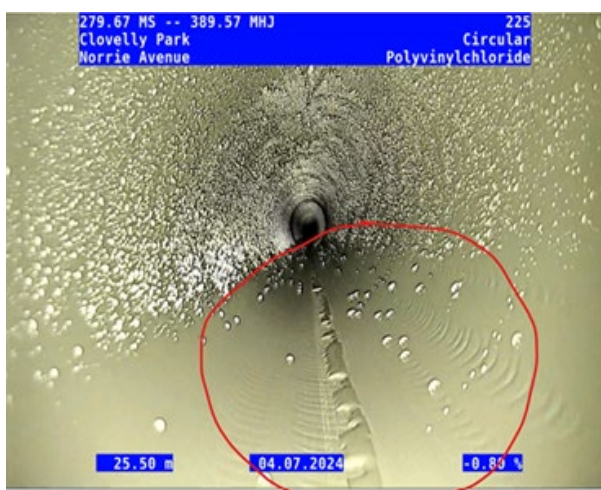
Bore ripples, which are expected in PVC pipes due to the extrusion process, may appear exaggerated under CCTV inspection. Camera lighting can cast shadows, and magnified views can distort perspective, making benign features seem more pronounced than they are in reality as shown in figure 1 and 2.

Figure 1: DN225 DWV bore rippling – CCTV view 1.

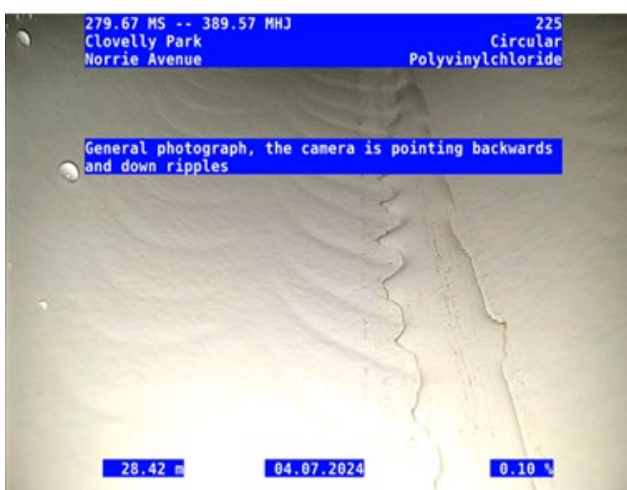
Figure 2: DN225 DWV bore rippling – CCTV view 2.

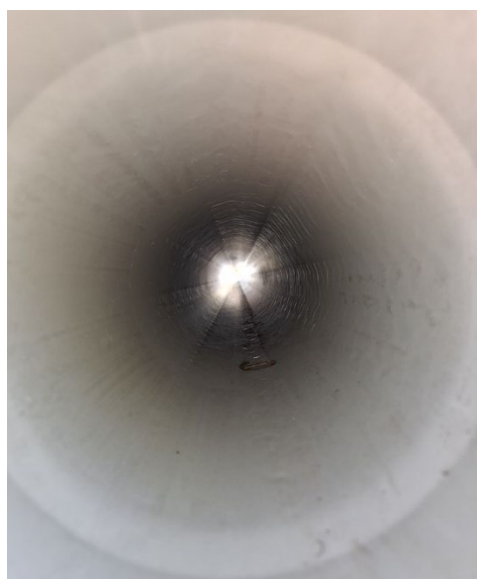
Figure 3: DN150 DWV bore rippling, photo taken at installation site with phone camera.

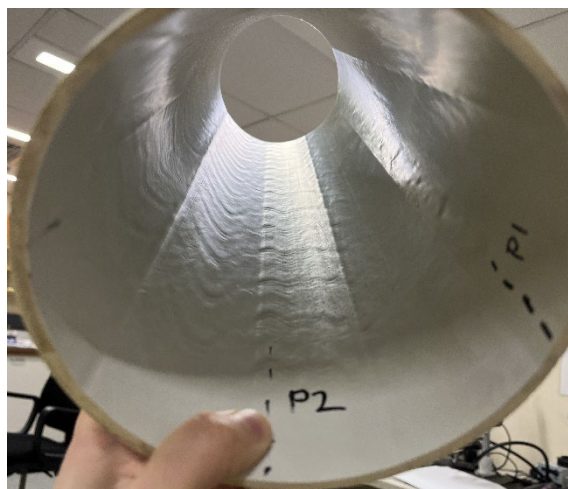
Figure 4: The same section of DN150 DWV bore rippling, photo taken in laboratory with phone camera.

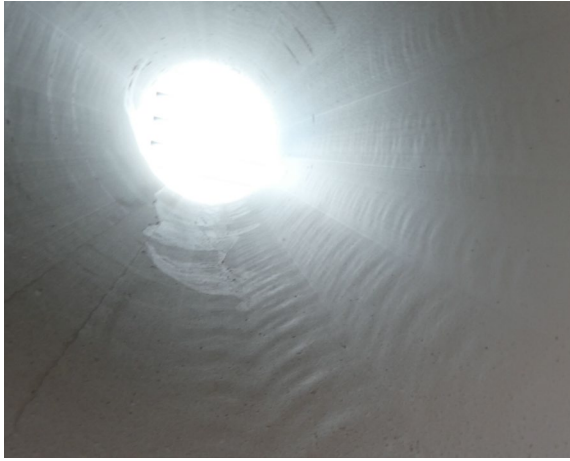
Figure 5: DN225 DWV bore rippling – view 1 photographed by phone camera.

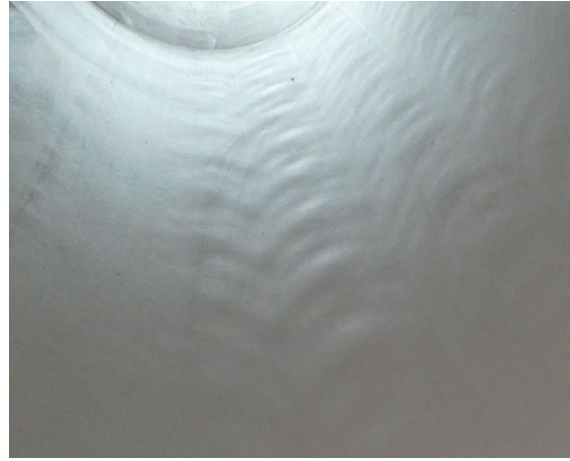
Figure 6: DN225 DWV bore rippling – view 2 photographed by phone camera.
