## VALIDATION OF THE LONG LIFE OF PVC PIPES

Steven Folkman  
Utah State University  
Logan, UT, USA

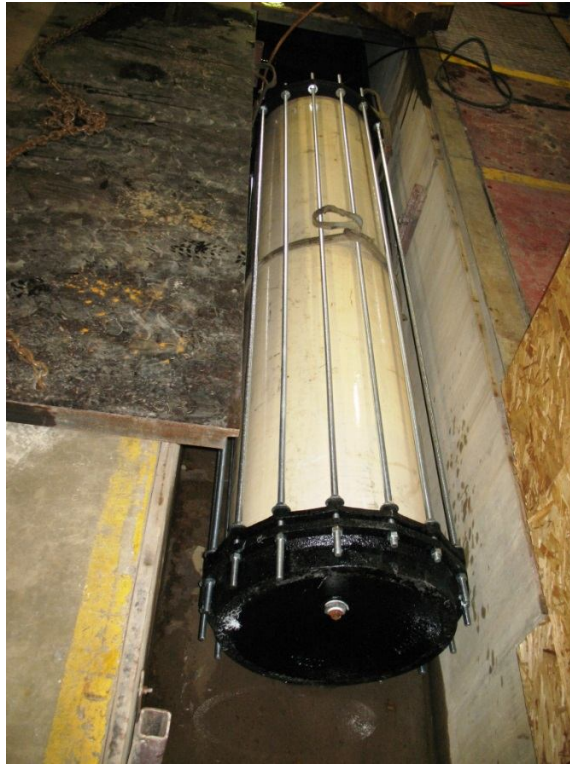
**Figure 1.** Photo of sample #3 prior to structural integrity testing.

In 2013, Folkman and Barfuss (21) reported on quality control tests on PVC pipe that had been in use for a number of years. Subsequent to that effort, additional quality control tests of excavated PVC pipes were completed. The pipes tested are summarized in Table 1 and had been in continuous use for between 20 and 49 years. Note that samples #1, 4, and 6 were manufactured under an early commercial standards CS 256 or PS 22-70. The CS 256 and PS 22-70 standards were replaced with ASTM D2241 and the standards are nearly identical. The tests included pipe dimensions, acetone immersion, and pressure tests. The burst pressure test was used for samples that were manufactured to CS-256, PS 22-70, and ASTM D2241 standards. The hydrostatic integrity test was applied to sample #3 which was made to the AWWA C905 standard. Table 2 lists the specifications used for these quality control tests. Figure 1 is a photograph of Sample #3 prior to the hydrostatic integrity test.
