Assessment of NDE Methods on Inspection of HDPE Butt Fusion Piping Joints for Lack of Fusion with Validation from Mechanical Testing

S.L. Crawford, S.R. Doctor, A.D. Cinson, M.W. Watts, T.L. Moran, M.T. Anderson
Pacific Northwest National Laboratory¹, USA

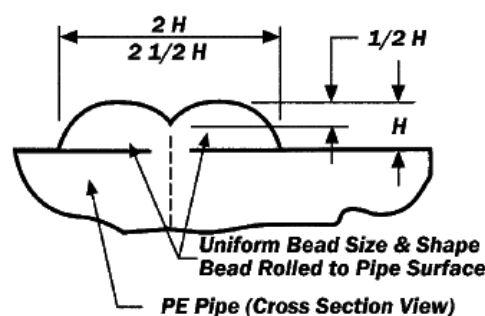
Figure 1 - Required weld bead dimensions and shape [1]

Each of the outer-diameter (OD) weld beads was examined for pitting or other anomalies in the v-groove as well as mis-shaped beads. Detected small holes in the v-groove were documented. Additionally, profiles were acquired from the 24 pipe joints at 8 equally spaced circumferential positions or every 45 degrees. The left and right weld bead widths, total width, and left and right bead heights were measured from these profiles. According to the ASTM Standard F2620 [1] on heat fusion joining of PE pipe, the weld bead should be rounded and uniform in size and shape on both sides and roll back to the pipe surface. The width of the beads should be approximately 2 to 2½ times the bead height. The v-groove between the beads should not be deeper than half the bead height (see Figure 1).

The v-groove depth was not specifically measured but cursory observations showed acceptance of the joints based on v-groove depth. Weld beads also did roll back to the pipe surface. The criterion that caused a rejection of more than half of the pipe joints was in the bead width-to-height comparisons. These values are plotted in Figure 2 for the 24 pipe joints. Data representing the 12 pipe joints that were made under the condition with fusion pressured applied during the heating cycle are on the right. All but 3 data points lie above the acceptable 2.5 bead width-to-height ratio line.
