PVC tops pipe joint performance tests

In tests conducted by the CSIRO Building, Construction and Engineering Division in conjunction with Iplex Pipelines, to measure the resistance of various pipe materials joints to root penetration, PVC pipes came out with a perfect score in that there was nil root intrusion in any of the samples tested.

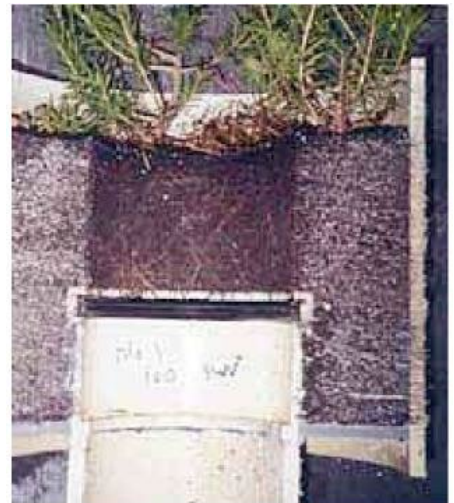
TEST HIGHLIGHTS FOR ELASTOMERIC SEAL JOINTS:

Root penetration accelerated trials over a 32-month period:

Types of pipe	Percentage of root penetration
PVC pipes	0%
Vitrified clay pipe	87%
Fibre reinforced concrete pipe	37%
