MICROPLASTICS AND PLASTIC PIPES

SHORT SUMMARY

Plastic pipes for drinking water purpose made of 9 different materials have in two studies been tested in conditions, similar to normal use. Based on the applied methods, no levels of microplastics above the detection limit were found in the samples.

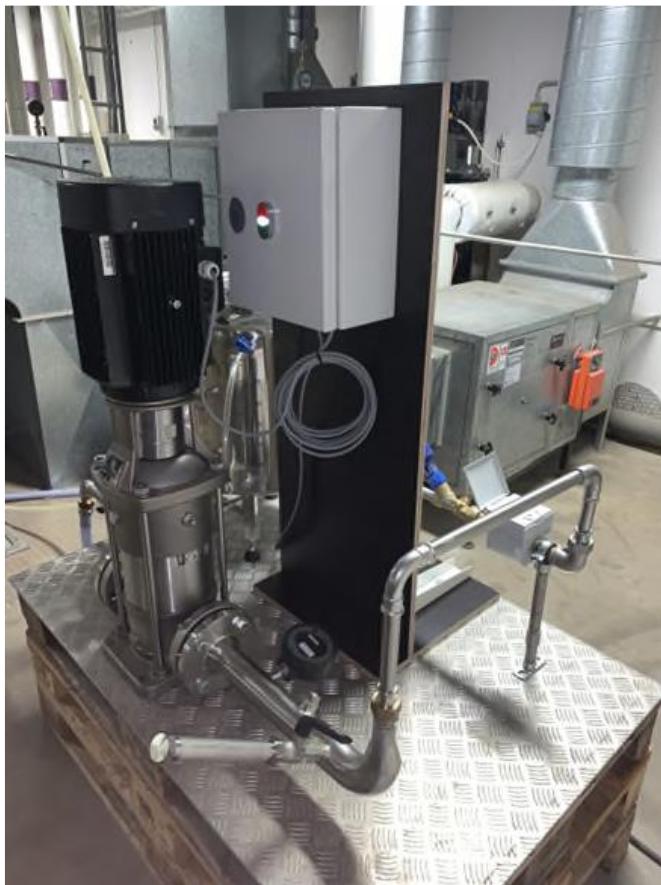
The pipes are assembled in a way that resembles daily routine work with deburring of ends, but with extra care in order to avoid internal impurities. The pipe between the red arrows shown is removed and replaced by the pipe to be tested.

The test setup consisted of the following components:

- Thermometer, pressure gauge and flowmeter
- Coupling devices and piping for connecting test pipes

During the pre-flushing, the container is filled with drinking water while the pump presses the water through the test pipe, the water meter, the reduction valve, the solenoid valve and to the drainage. During the pre-flushing, the temperature in the container and a momentary value of the flow are recorded.
