# TP001 THE RESISTANCE OF ELASTOMERIC SEAL PIPE JOINTS TO TREE ROOT PENETRATION

ISSUE 01 / JULY 2003

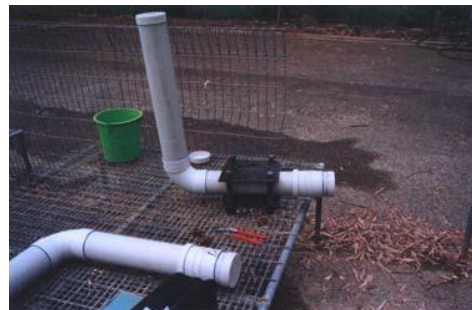
**FIG.2 HORIZONTAL ASSEMBLIES. ONE WITH 7.5% DEFLECTION APPLIED TO THE SPIGOT VIA 2 PARALLEL STEEL PLATES**

**No root intrusions were observed in any of the commonly used PVC joints. Intrusions were however observed in some joints where the interface pressure had been reduced to 0.04 - 0.2 MPa compared to the minimum specified pressure of 0.4 MPa. An interface pressure of 0.38 MPa was even found to resist intrusions when the spigot had been grossly distorted by compressing between parallel plates by 7.5% of the original diameter.**

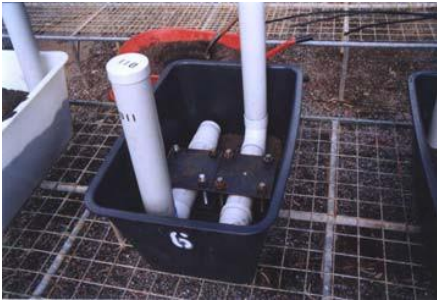
**FIG. 3 TWO HORIZONTAL ASSEMBLIES WITH 7.5% DEFLECTION APPLIED AND READY FOR BURIAL**

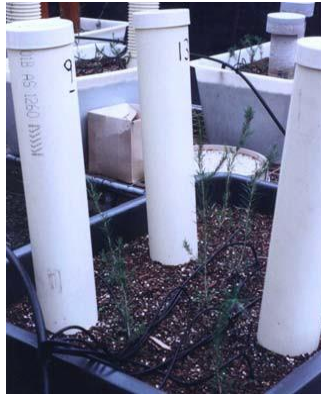
**FIG. 4 HORIZONTAL ASSEMBLIES WITH MELALEUCA SEEDLINGS**

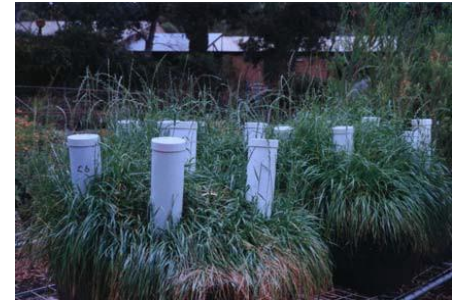
**FIG. 5 ASSEMBLIES WITH ESTABLISHED RYE GRASS**

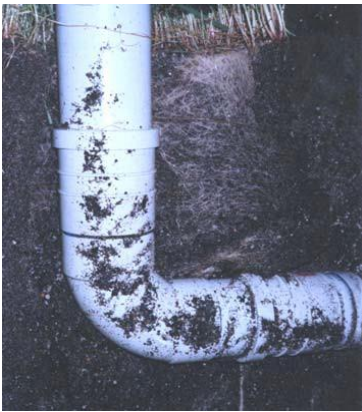
**FIG. 6 RYE GRASS ROOTS BINDING ALL THE SOIL TOGETHER, INCLUDING THAT BELOW THE ASSEMBLY**

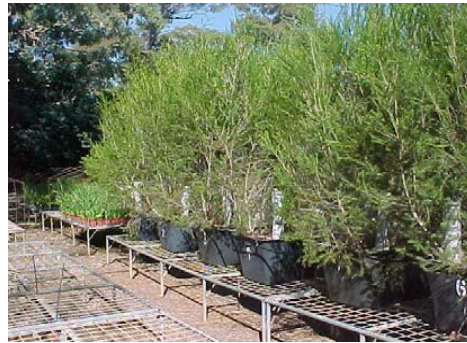
**FIG. 7 ASSEMBLIES WITH ESTABLISHED MELALEUCA ARMILLARIS**

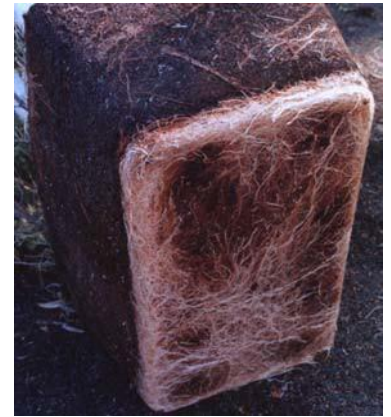
**FIG. 8 MELALEUCA ROOTS BINDING ALL THE SOIL TOGETHER**

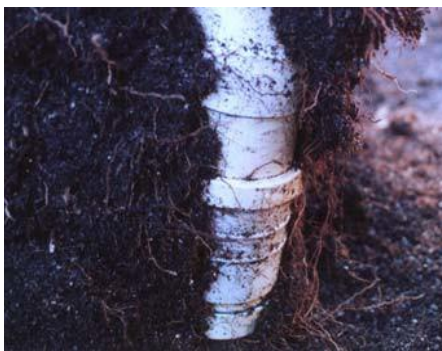
**FIG. 9 MELALEUCA ROOTS SURROUNDING THE JOINT**

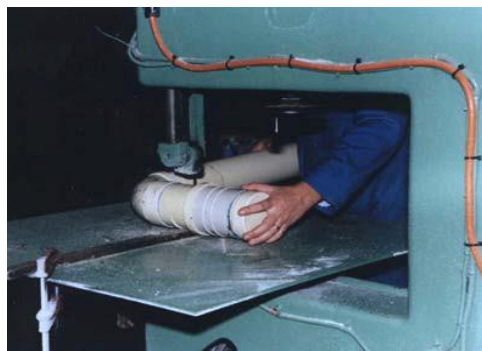
**FIG. 10 CUTTING A PVC ASSEMBLY WITH A BANDSAW**

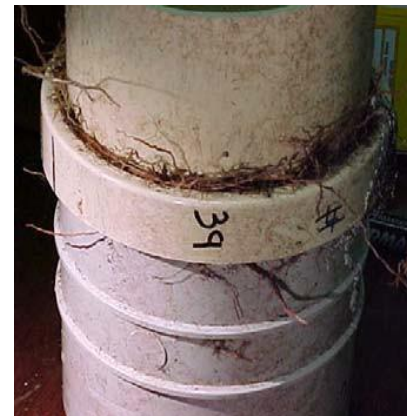
**FIG. 11 MELALEUCA ROOTS GROWING IN THE CREVICES AT THE SOCKET OF A PVC JOINT**

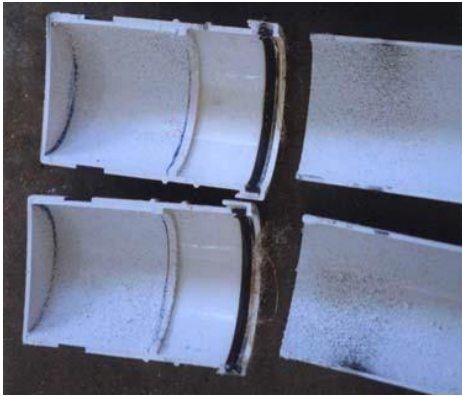
**FIG. 12 DISSECTED PVC ASSEMBLY SHOWING ROOTS HAVE NOT PENETRATED PAST THE SEAL**

**Despite the prolific growth, roots did not penetrate past any of the seals, even those having a contact width or interface pressure less than nominated in Australian Standard AS 1260- 1984.**

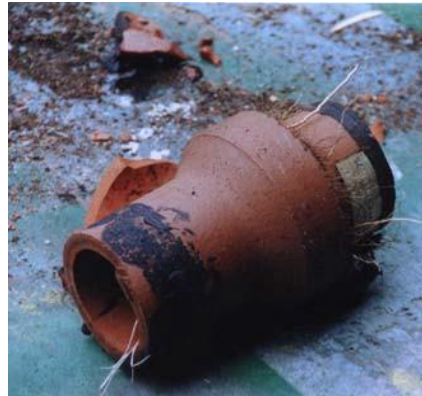
**FIG. 13 VC ROLLING RING JOINT WITH ROOTS HAVING ENTERED PAST THE SEAL**

The VC pipes performed worst of all the pipes with 7 out of 8 rolling-ring joints being penetrated within 32 months when tested with melaleuca armillaris.

**The experience with the second series of PVC joints illustrates the intrusion of the roots in the VC joints was not due to the open socket design. It was concluded that surface roughness and porosity of the pipe material were contributing factors to the poor performance.**

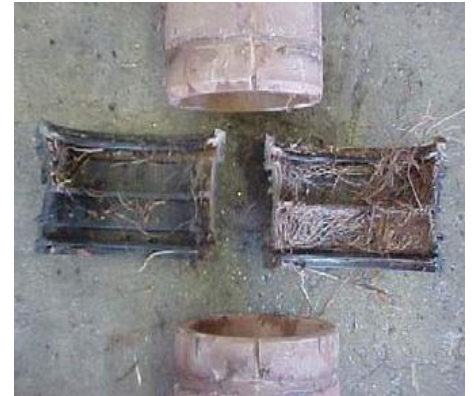
**FIG. 14 VC PIPES JOINED WITH A PLASTICS COUPLING SHOWED A MASS OF ROOT INTRUSIONS WHEN DISSECTED.**

**Spigoted vitrified clay pipes** with plastics couplings and elastomeric seals. Rolling-ring VC joints have now been superseded by plain ended pipes joined with elastomeric seal couplings made from a polyolefin such as polypropylene.

**There is evidence that these pipes also experience tree root intrusions and might not offer any long-term benefit compared to the rolling-ring joints that performed poorly in the tests.**
